Hardwood Floors

PICTURES FROM THE FIELD

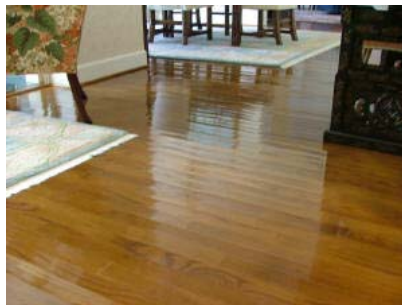
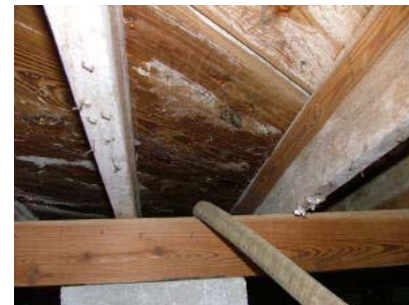
Legends Terrace, Sneeh Farm, Mt. Pleasant, SC - These Kitchen hardwood floors were cupping due to elevated crawl space moisture exacerbated by the use of under-cabinet registers and congested ductwork.

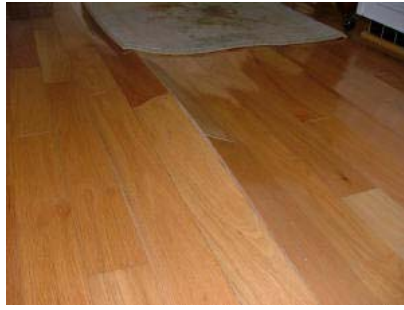
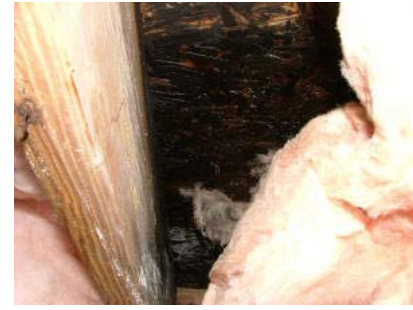
White Point Court, James Island, SC - Hardwood floors throughout this James Island home were cupping due to elevated subfloor moisture largely due to interior temperature control.

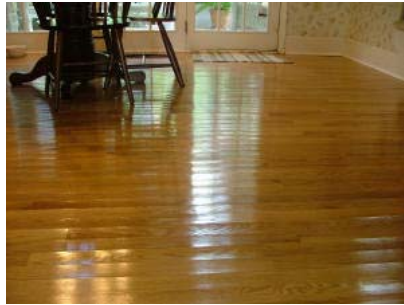
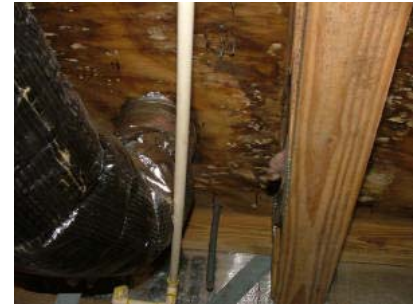
Harbor Place, James Island, SC - The subfloor under these hardwood floors was saturated causing the floors above to buckle.

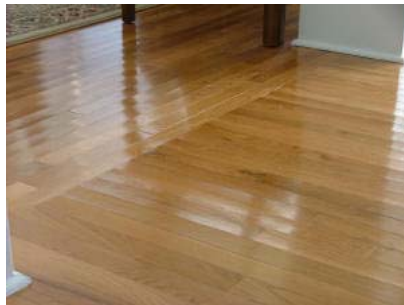
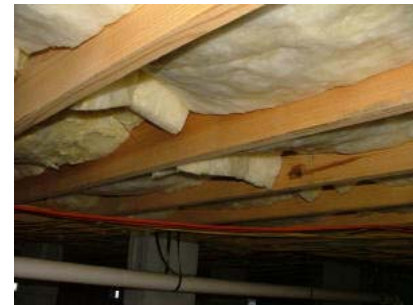
Millbrook Court, Longpoint, Mt. Pleasant, SC - Widespread cupping of the hardwood floor in this Mt. Pleasant home was caused by elevated crawl space moisture.

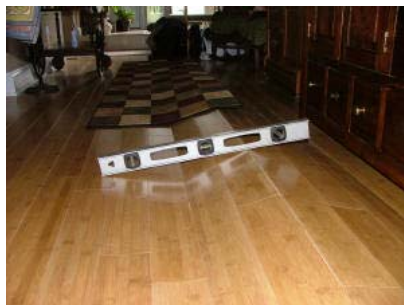
Clearspring Drive, Ocean Neighbors, James Island, SC - Although the crawl space of this James Island home appeared dry, the elevated relative humidity (as compared to that on the inside) was enough to cause these floors to cup.
